KMC/KMMG Top Issues Product Quality Report March 7, 2013 Product Quality

### TF/QF/XM/SL - Panorama Sunroof Glass Shatter (Moved To Monitor 1/3/13)

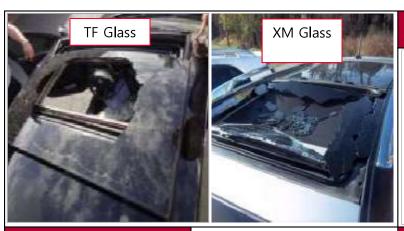
- ➤ Consumer complaints of Panorama Sunroof Glass shatter while driving @ highway speeds.
- Consumers are reporting a loud explosion noise heard; then glass fragmentation falls into interior
- > Consumers are reporting Panorama Sunroof Glass shatter while operating sunroof or closing doors

- >KMA has issued two QIR's for XMa for this concern 7/12/2011 and QIR ACD-BO-11116 was issued on 12/15/2011 for QF.
- >KMA / KMMG /Supplier have conducted multiple Customer Complaint "Go & See" most recent on (11/30/2012)
- >KMA / HATCI CPG has completed a Controlled Durability Test for the Panorama Glass on both XMa and QF (11/21) >Continuous monitoring of field complaints
- Latest Investigation in AL inconclusive XMa
- ➤ Completed (2) investigations in Texas 2/11/13 (TF HEV)

- > This concern was raised during QF EWR and multiple investigation were conducted with supplier to identify "Root Cause".
- ➤ Glass samples were recovered and sent to Supplier via NAQC (10/30)

- ➤ KMA Request KMC & Supplier TFT Assistance for Further Investigation to "Root Cause" as Issue is Complex
- > KMC to investigate supplier sunroof heat treatment variability and material characteristics (heat expansion).
- > KMC to investigate body opening cavity variability and sunroof dimension variability for potential interference
- > KMC to investigate glass sample for material quality
- ➤ KMA request results of glass analysis conducted by supplier (3/7/2013)
